# Typical wear mechanism of 2-stroke exhaust valves

Extend Component Life and Time Between Engine Overhauls.

*Dr. Ing. Holger Fellmann, Head of 2-stroke department & service; Märkisches Werk GmbH*

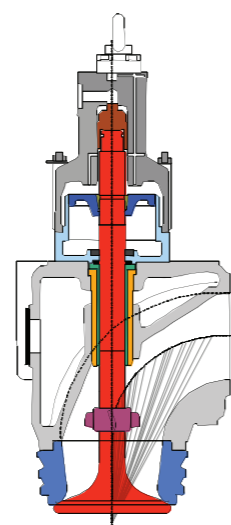
- Valve drive or hydraulic actuator
- Air cylinder
- Valve housing
- Valve guide
- Valve spindle
- Bottom piece or seat ring

*Figure 01: Main components of an exhaust valve*

The design of the exhaust valves of all three engine builders are different in details, but the general function is the same, see figure-01. The main components of MC, RTA and UEC are:

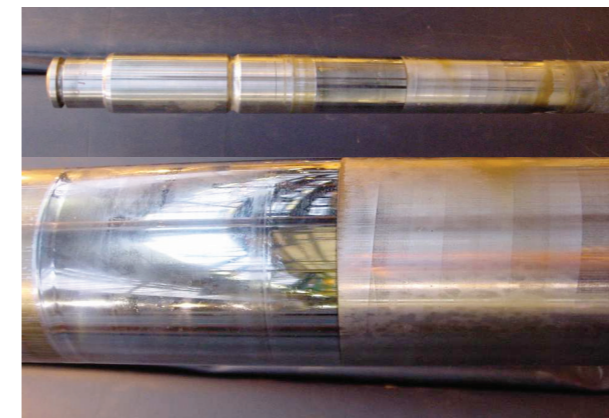
Adhesion and abrasive wear is very often found in the stem sealing area of hard chromed, MC valve spindles (see figure 02). Usually the limit of this stem diameter is reached after 12,000 - 18,000 hrs. MC valve spindles with HVOF-stem coating, as well as RTA- and UEC valve spindles with hard-chromed stems, reach a TBO (time between overhaul) of 24,000 - 36,000 hrs.

*Figure 02: Physical adhesion and abrasive wear of a hard-chromed valve spindle (MC-type after 15,000 hrs)*

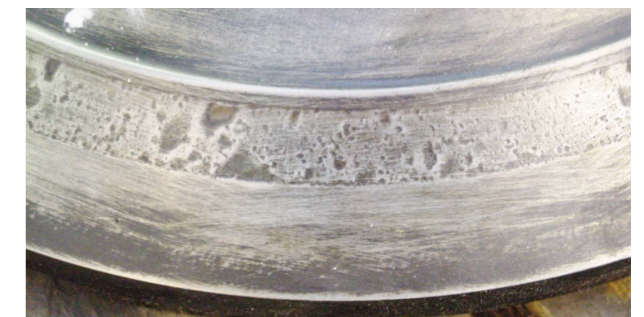
Together with high seat pressure and a higher seat hardness of the bottom piece, the MC-type shows the highest probability and intensity of dent marks with TBOs of 6,000-18,000 hrs (see figure 03). The seats of RTA- and UEC-types require overhauls after 12,000 - 36,000 hrs.

*Figure 03: Typical dent marks of the seat of a valve spindle (MC60-type Nimonic after 8,300 hrs)*

The probability and intensity of dent marks is directly related to the material combination of valve spindle seat and bottom piece. The hardness of the seat material of RTA- and UEC-type is about 400 HV for valve spindle and bottom piece, the hardness of the MC-types is about 400 HV for seat of valve spindle and about 500 HV for the seat of bottom piece.

Seating pressure and sealing velocity are also relevant factors for dent marks. The MC-type has a higher seating pressure (>700 bar) than the UEC- and RTA-type (about 550 bar). Typically, 550 bar gives good sealing and low wear. (KINGSTON-JONES, THOMAS, RADCLIFF 1990)

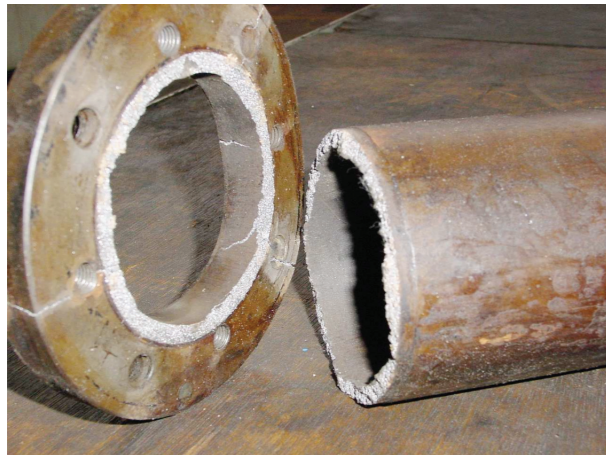
To disassemble exhaust valves, hydraulic power is usually necessary to remove the valve spindle from the valve guide. In some cases the sticking of the valve spindle is so extreme that the valve guide breaks during the operation (see figure 04a and 04b).

Figure 04a: Breakage of the valve guide during valve spindle disassembling

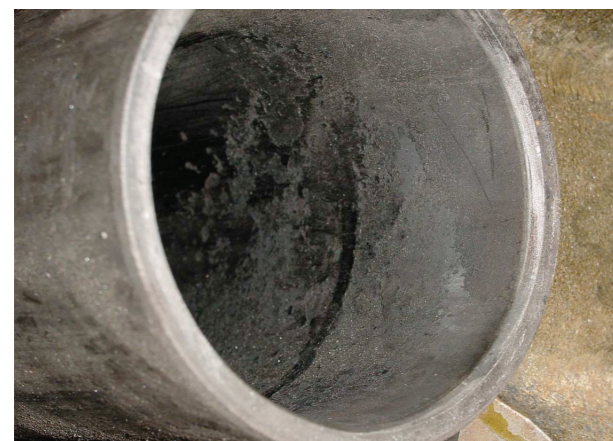
Depending on the design of the valve guide, its inner diameter will display more or less deposit buildup. Exhaust gas enters into the clearance between valve spindle stem and the inner diameter of the valve guide, which allows deposits inside the guide (see figure 04). Due to this, MC-types need a replacement of the valve guide between 6,000 - 8,000 hrs to minimize the risk of the valve spindle sticking in the guide.

Figure 04b: Typical deposits of inner diameter of valve guide (MC70-type after 8,200 hrs)

The valve guide of UEC- and RTA-types will show the same deposits, but after a much longer period of time (TBO is 24,000 to 36,000 hrs).

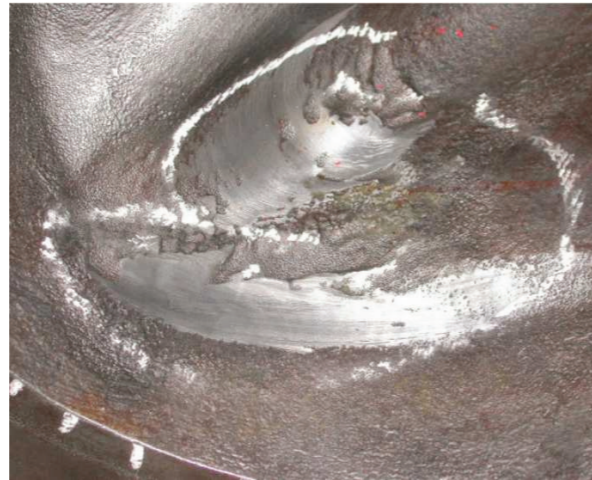
Figure 05: Low temperature corrosion of valve housing (MC-type 43,700 hrs)

Heavy fuel contains high amounts of sulfur (up to 5%). If there is an exposed surface where the temperature is below the dew point of sulfuric acid, the acid condenses into liquid and can attack the metal surfaces. If a large amount of concentrated sulfuric acid condenses, it can attack the valve housing, bottom piece, valve guide and valve spindle stem. Sulfur acid has an extremely corrosive effect on cast iron (BEHRENS, GROTH 1990).

Nearly all components of the exhaust gas channel show some low-temperature corrosion (see figure 05-07).

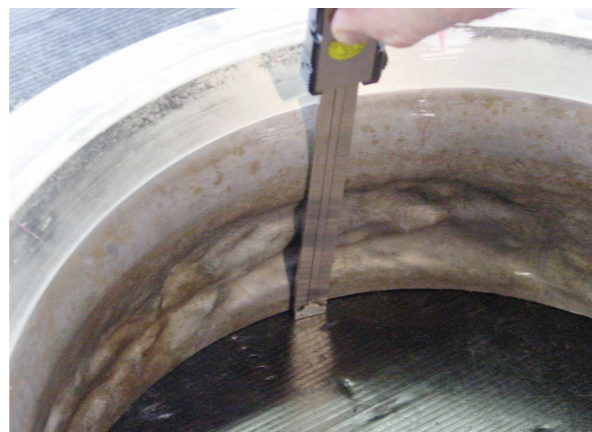
Figure 06: Low temperature corrosion of bottom piece (RTA-type after 28,420 hrs)

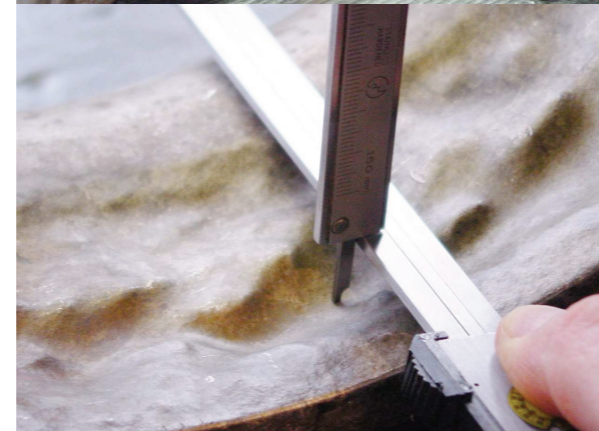
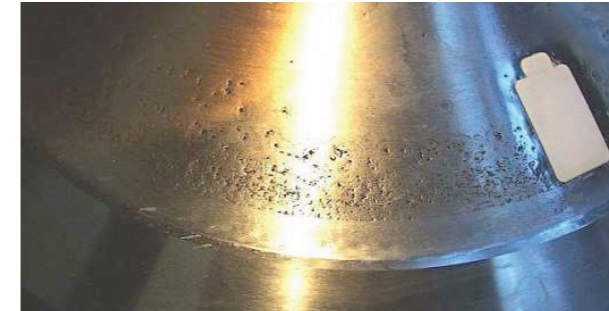
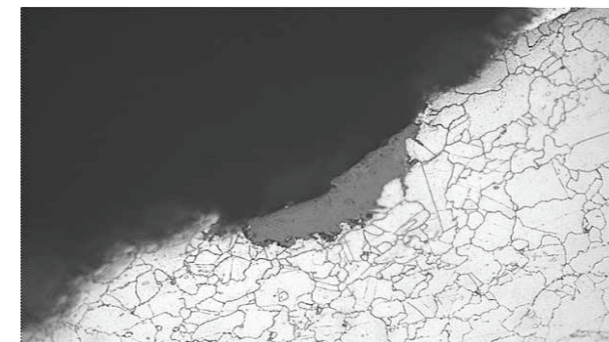
Figure 07: Low temperature corrosion (pitting corrosion attack) of under head radius of valve spindle (MC60-standard / 22,700 hrs)

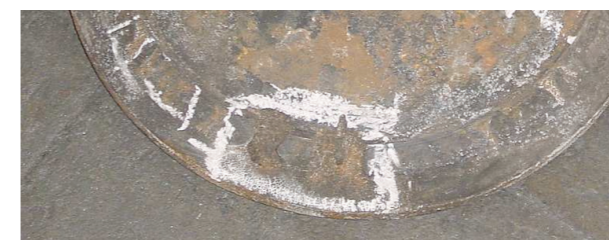
As a result of the above-mentioned physical process, the following wear mechanism can be described. Hard salt deposits on the seat surfaces of the valve spindle lead to dent marks caused by each closing stroke of the valve spindle. This can lead to crucial micro gas channels, which will grow over the time (NANDA, 2003). Because of the high temperature, the salt deposits reach their melting point, then the "cobble stone corrosion" starts (see figure 08) at the seat and finally leads to blow-byes (UMLAND 1975, RITZKOPF 1975). Result: The whole exhaust valve has to be replaced.

Figure 08: "Cobble stone corrosion" appearance of valve spindle failure through high-temperature corrosion (MC60 Standard-type)

The bottom of the valve spindle is mostly operating in the critical area of the high-temperature corrosion seen as "cobble stone corrosion". The wear rate is between 0,2 - 1,0 mm / 1,000 hrs. depending on valve material and type of engine. The limit for remanufacturing is only reached after 12 mm. This leads to a TBO of about 12,000 - 60,000 hrs. Figure 09 shows micro cuts of Nimonic with high-temperature corrosion.

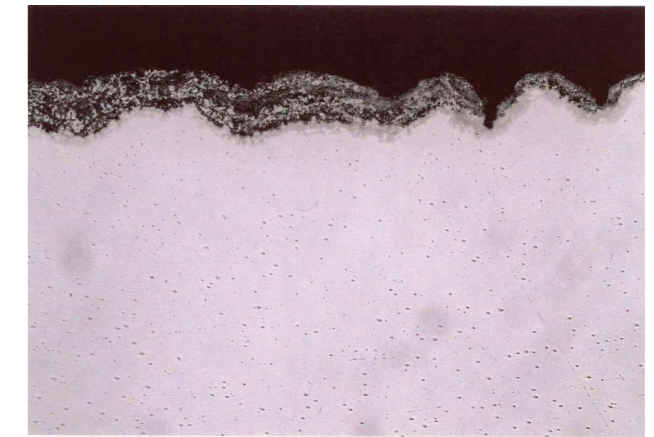
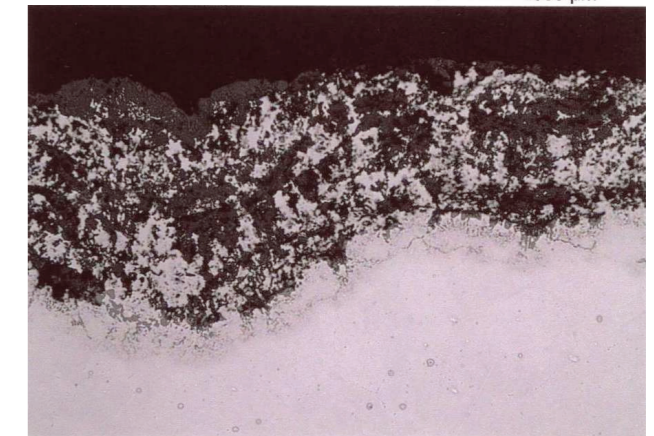
25 : 1 1000 µm

100 : 1 200 µm  
Figure 09: Micro cuts of Nimonic with high-temperature corrosion.

High-temperature corrosion in heavy fuel engines is caused by the presence of Sulfur, Vanadium and Sodium in the fuel. Vanadium and Sodium are contained in heavy fuels at ratios up to 600 ppm and 200 ppm respectively (ISO 8217, 2003). This can build up sodium-vanadyl-vanadates in different structures during the combustion process. These semi-liquid, sticky, low-melting point salts together with gases containing sulfur oxide are a definite cause of corrosion due to their oxygen transitions (HESSE 1981, BLUDSZUWEIT 2000).

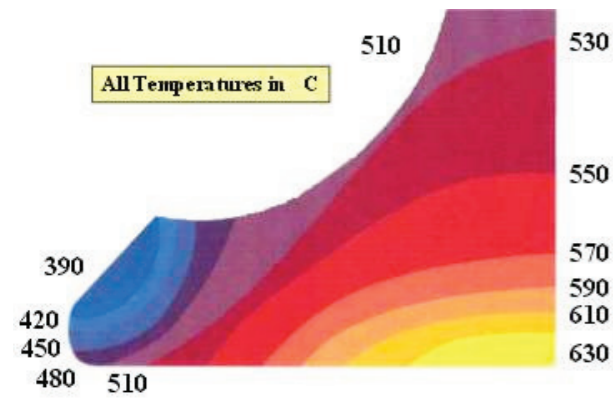
The valve spindle is the component with the maximum thermal stress. Most of fatigue problems are documented at the valve spindles. Figure 10 demonstrates a typical heat distribution across a Nimonic valve head.

Figure 10: Typical temperature distribution of a Nimonic exhaust valve head

The maximum thermal stress takes place during the warm-up period. During this period the temperature at the center of the valve bottom and the seat reaches the maximum difference. Under regular operating conditions the temperature distribution is much lower. The mechanical load of a valve spindle is nearly constant between warm-up and regular operating, see figure 11.

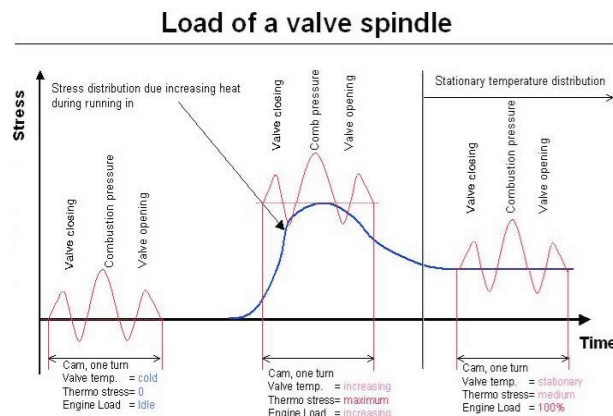
Figure 11: Mechanical and thermal load as function of running in and stationary operation

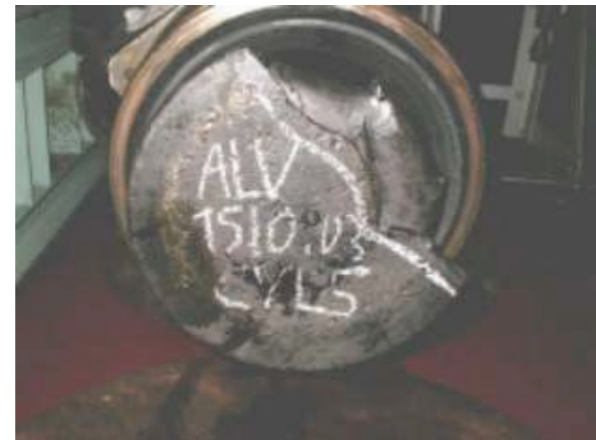
There are two typical failure reasons. One is a crack that starts in the under head radius. After the micro cracks get to a critical length, the speed of the crack growth increases. A catastrophic failure follows, with parts of the spindle dropping down into the combustion chamber (see figure 12 and 13).

Figure 12: Catastrophic failure of a repaired valve spindle (RTA72 Nimonic-type 740 hrs after repair)

The design of valve spindles usually takes into account the combination of mechanical and thermal load of the engine. But, the addition of residual stress, caused by non-professional forging, welding or heat treatment during the manufacturing process can be critical. Also, unprofessional repairs, including welding and heat treatment, can add further residual stress, leading to catastrophic failures. In particular, Nimonic valve spindles require excellent welding and heat treatment.

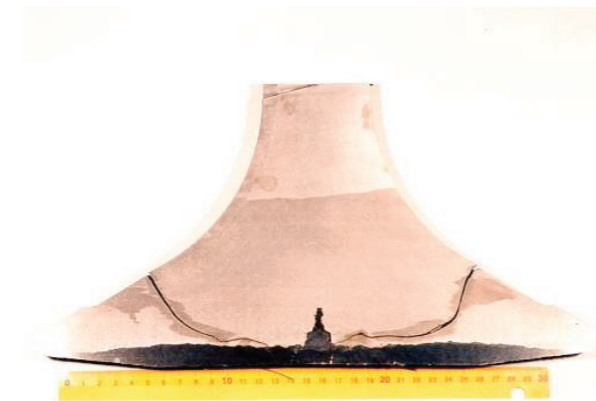
Figure 13: Macro cut through the center of a valve head (RTA62 Nimonic-type 6,430 hrs after repair)

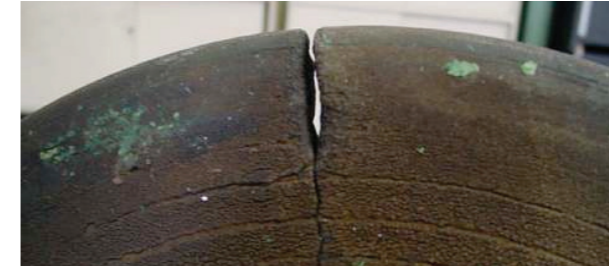
The second failure reason is: Micro cracks starting in the outer diameter of the valve bottom. After reaching the seat area blow-byes are created and the valve spindle is destroyed (see figure 14).

Figure 14: Failure of a valve spindle (RTA84 Nimonic type 5,270 hrs after repair).

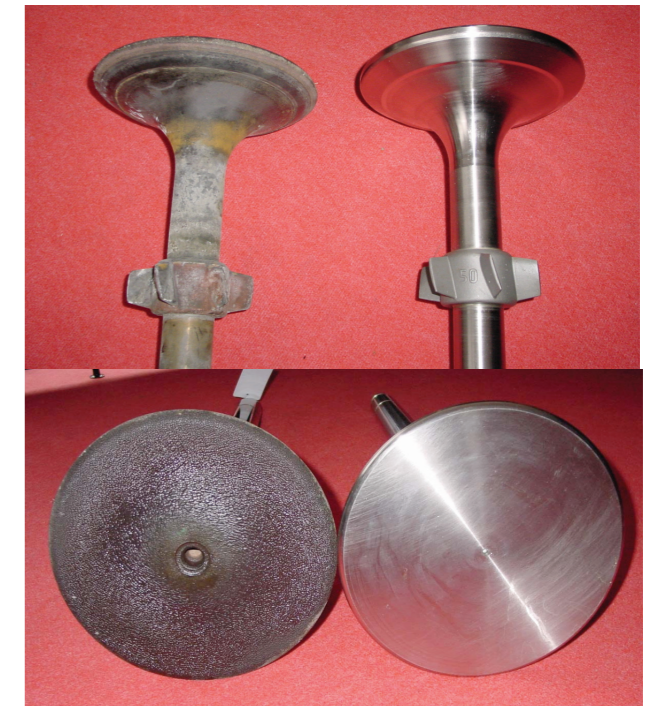
Nimalike is used in two ways: To extend the lifetime of a standard valve spindle to a lifetime similar to Nimonic, or to remanufacture Nimonic valve spindles in a way that leads to “close to new” conditions after the process (see figures 15 a/b).

Figure 15 a/b: Nimalike spindle before and after remanufacturing

Standard valve spindles can be upgraded with the Nima-like-procedure to achieve a lifetime similar to Nimonic. The procedures used to remanufacture Nimonic valve spindles (including welding and heat treatment) are critical to preventing low-cycle fatigue. An inadequate repair leads to catastrophic failure. While standard valve spindles have disadvantages with respect to low- and high-temperature corrosion, they do have advantages regarding low-cycle fatigue.

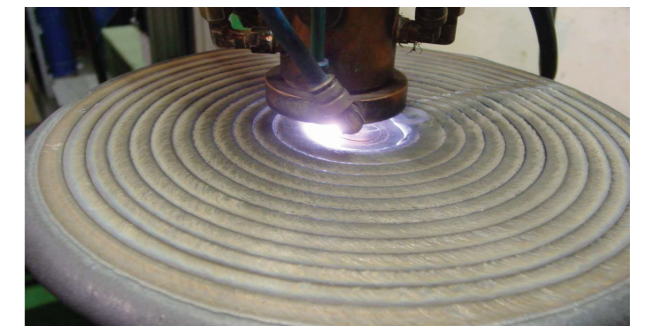
The competence to perform this remanufacturing method is a combination of long-time experience in the field and manufacturing technology. The experience is coupled with continuous improvement of manufacturing processes and intensive R&D in the fields of metallurgy and welding processes (see figure 16).

Figure 16: PTA-welding

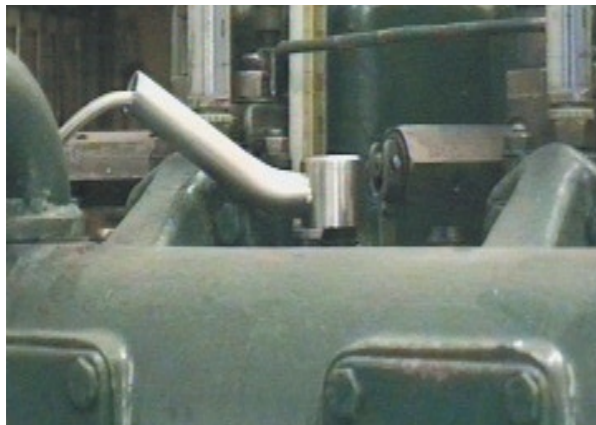
For this reason MWH provides the “Leakage Measure System”, a mobile diagnostic system which is able to detect leakages at the cylinderhead to prevent fatal failures of a running engine. The principle is based on measurement of ultrasonic sound by using one simple and robust sensor (WEHNER, ALBERT 2001).

Figure 17:  
Leakage Measure System onboard in use

With this very compact measurement system, the engine user is able to find out what condition the engine is in and when the next actions have to be taken for service.

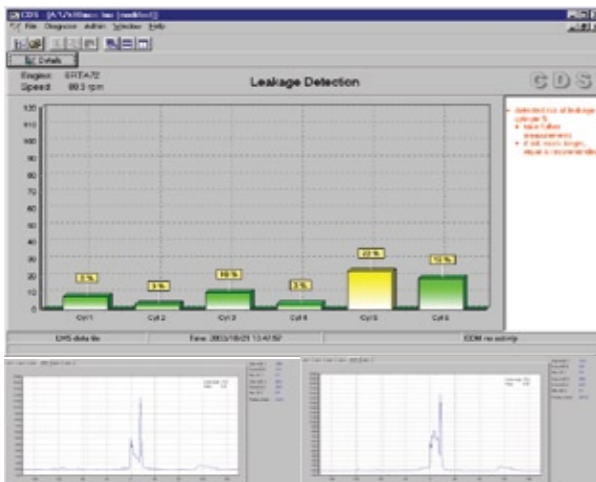
Figure 18:  
Documentation of the result of leakage detection and valvetiming/ignition

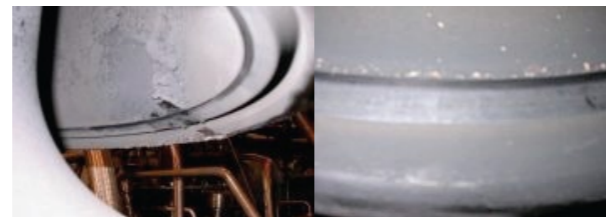
First field tests are ongoing with a MC70 engine. Inspections have proven that the Turnomat works as designed (see figure 19).

Figure 19:  
Seat ring and valve spindle show no dent marks after app. 1,000 hours.

The valve rotator forces an accurate, reliable valve turning during valve closing. The Turnomat principle is simple and surprisingly effective: The forced rotational movement causes a defined rotational energy for the valve at the instance of seating. This brings about the desired polishing effect, removing combustion deposits between valve spindle and valve seat and, at the same time, optimizing the heat exchange to the cooler valve seat.

By using the new development of the 2-stroke Turnomat, the critical build up of deposits between valve spindle and seat can be greatly reduced. Ongoing field tests have also proven the benefit of the Turnomat in preventing sticking of the valve spindle in the guide.
